Gas space heating appliances with damaged heat exchangers

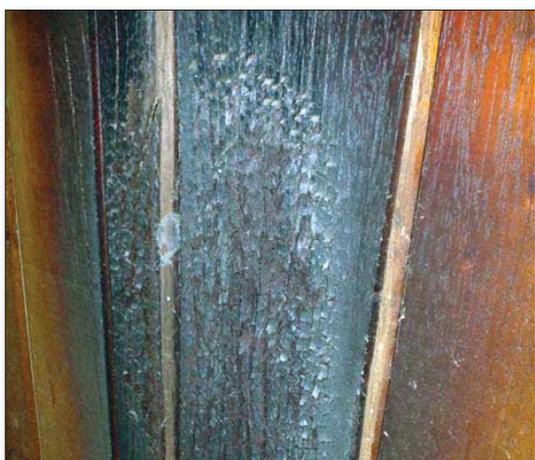
Burned timber panel on casing

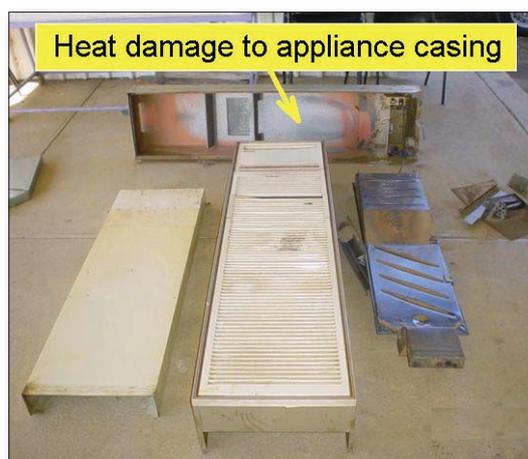
Heat damaged appliance casing

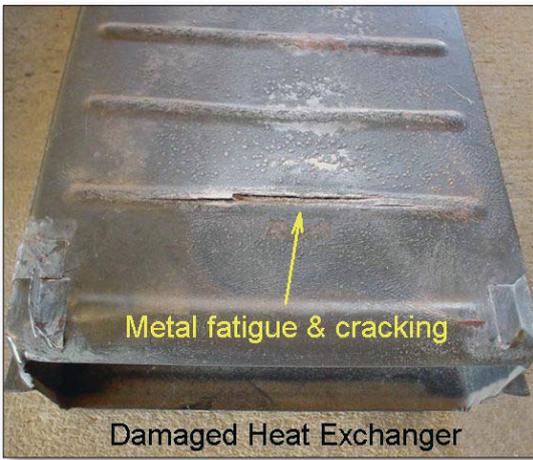
If a heat exchanger does split, the burnt flue gases that are normally vented safely to the flue could leak into the room through the split. This is a potentially dangerous situation to persons in the room, particularly if carbon monoxide is present in the flue gases.

Damaged heat exchanger

The Gas Act requires any such damage should be brought to the attention of the owner or user, and in the interest of their safety, the appliance should be turned off. The appliance should also be marked by a 'do not operate' safety tag to identify there is an issue.

This tag must not be removed until the matter is rectified and the appliance can be operated safely. It may be appropriate to advise your customer on whether spare parts are available and an estimated cost of repairs. It might also be that a replacement appliance is the best option and you should advise your client accordingly.

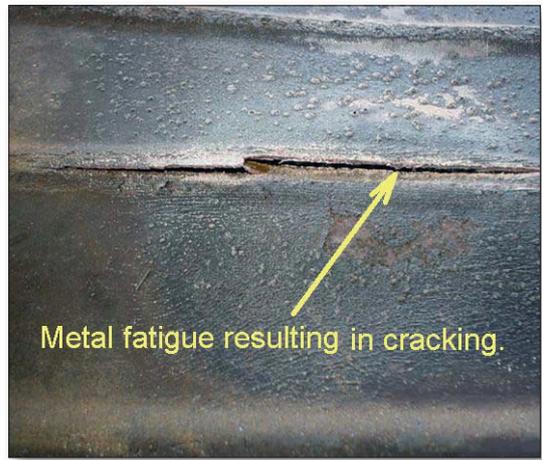
A split in a heat exchanger may be caused by the age of the appliance, metal fatigue or other related factors and this kind of damage is generally not something that can be economically repaired.

Metal fatigue and cracked heat exchanger

If you are working on an old gas space heating appliance and notice that it has developed a crack or split in the heat exchanger then it should be condemned as unsafe to use and turned off.
