Damage Assessment Criteria for the Classification of Statutory Write-Offs

National Motor Vehicle
Theft Reduction Council

Austroads

Published July 2011

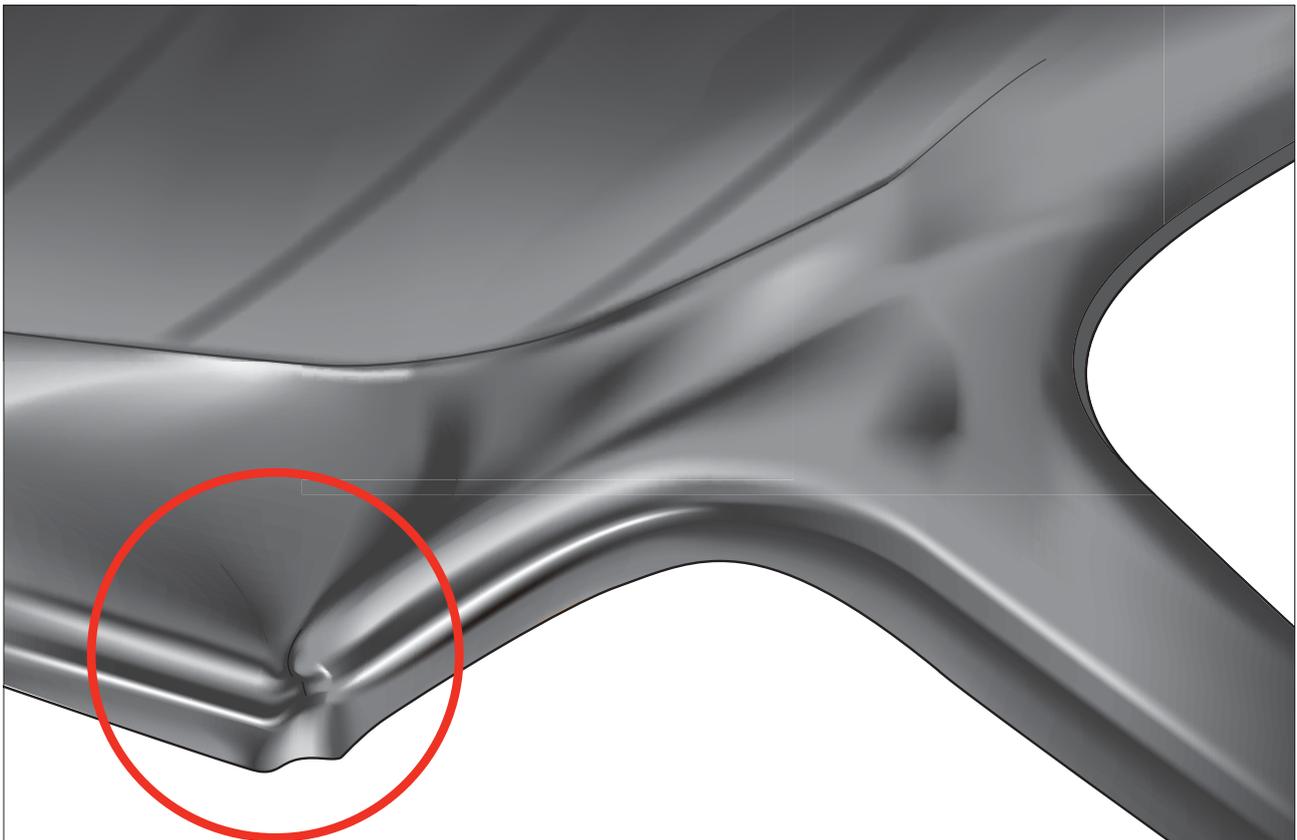
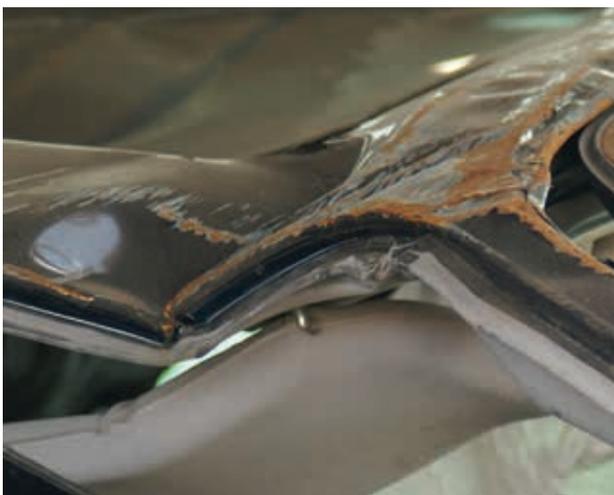
1.1 Roof – buckled

View of the roof, windscreen header, front left door header and 'A' pillar. The roof has been structurally loaded such that the windscreen header has buckled.

The criteria to be used for the vehicle's roof is that if the roof has been loaded such that individual structural element(s)/member(s) have been structurally: fractured, cut, cracked, buckled and/or is folded over onto itself, then the roof has an area of structural damage.

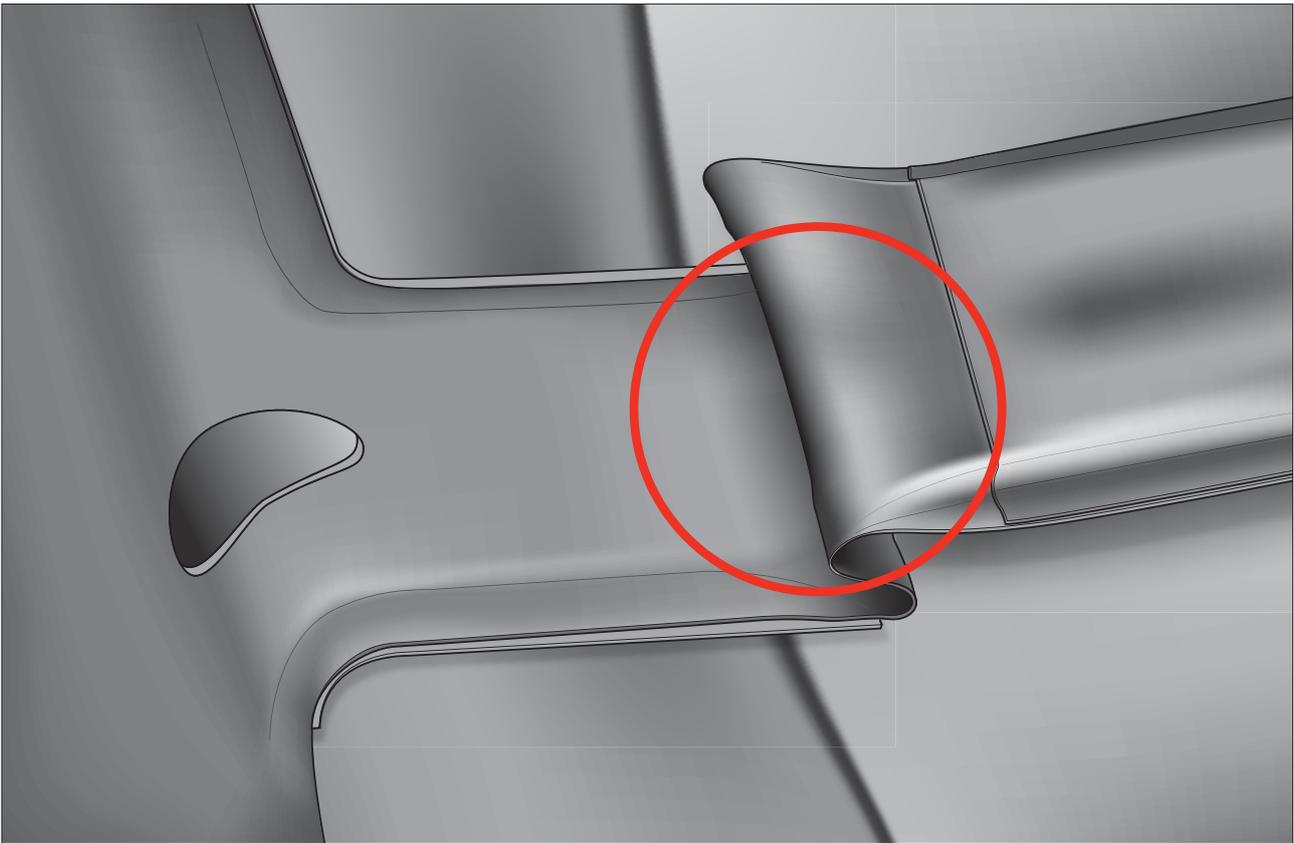
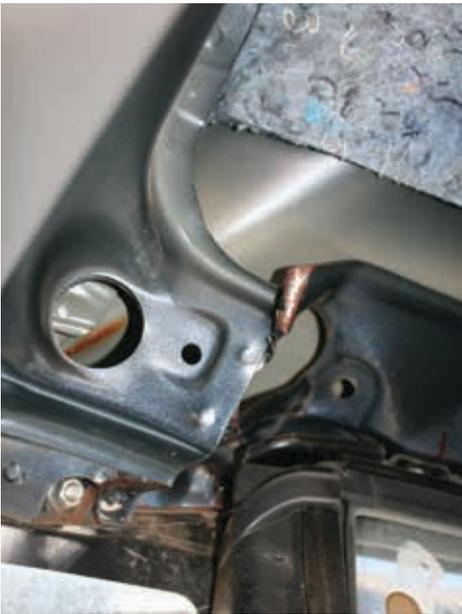
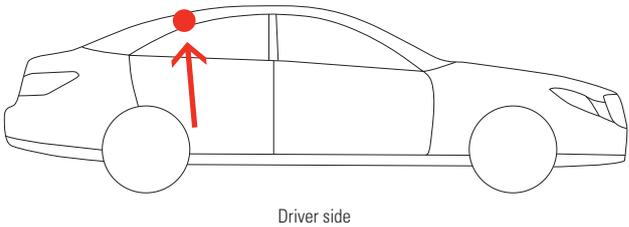
1.2 Roof support rail – folded

Internal view of lateral roof rail which due to structural loading has folded over onto itself.

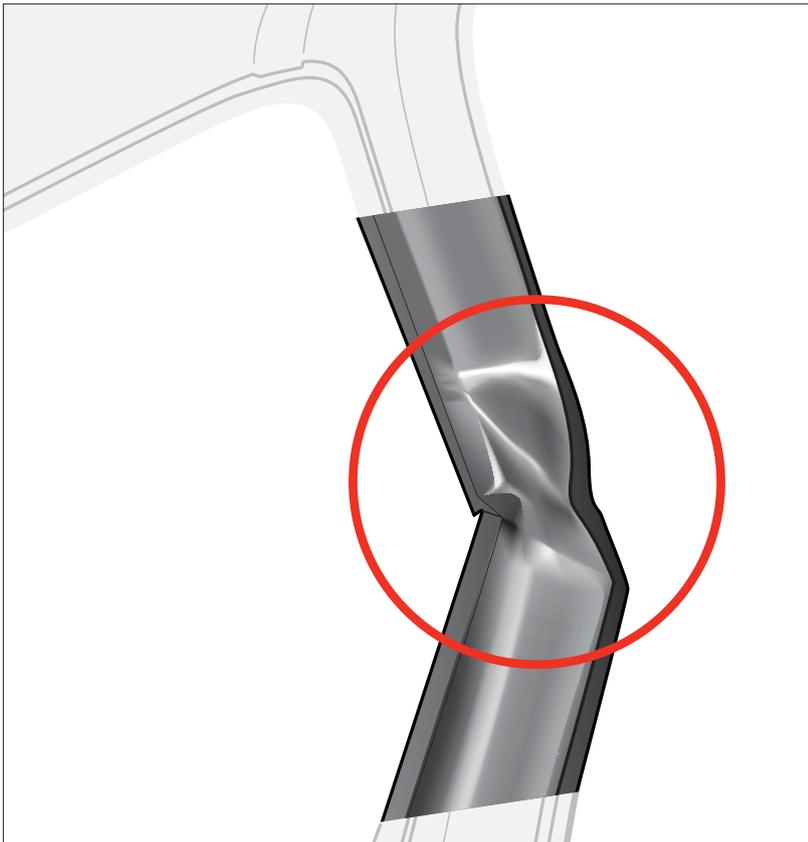
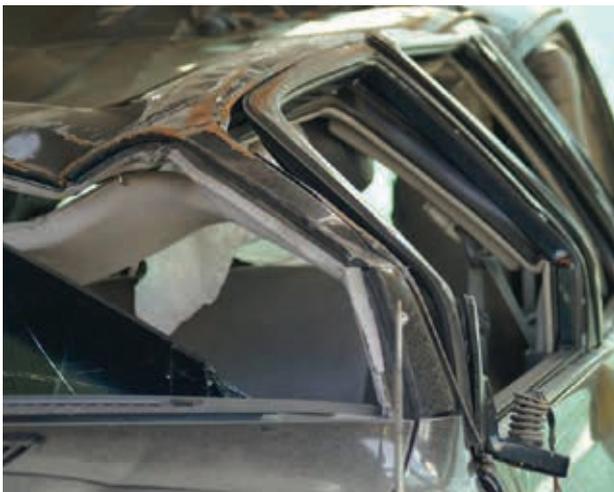
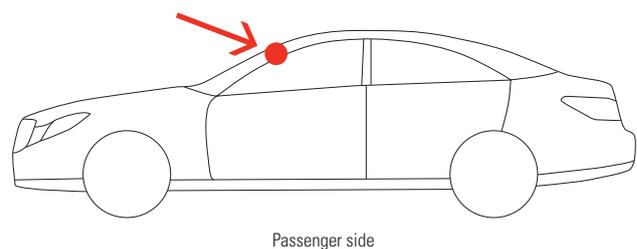
2.1 'A' pillar – buckled

A vehicle 'A' pillar which has failed by buckling due to structural loads to the roof.

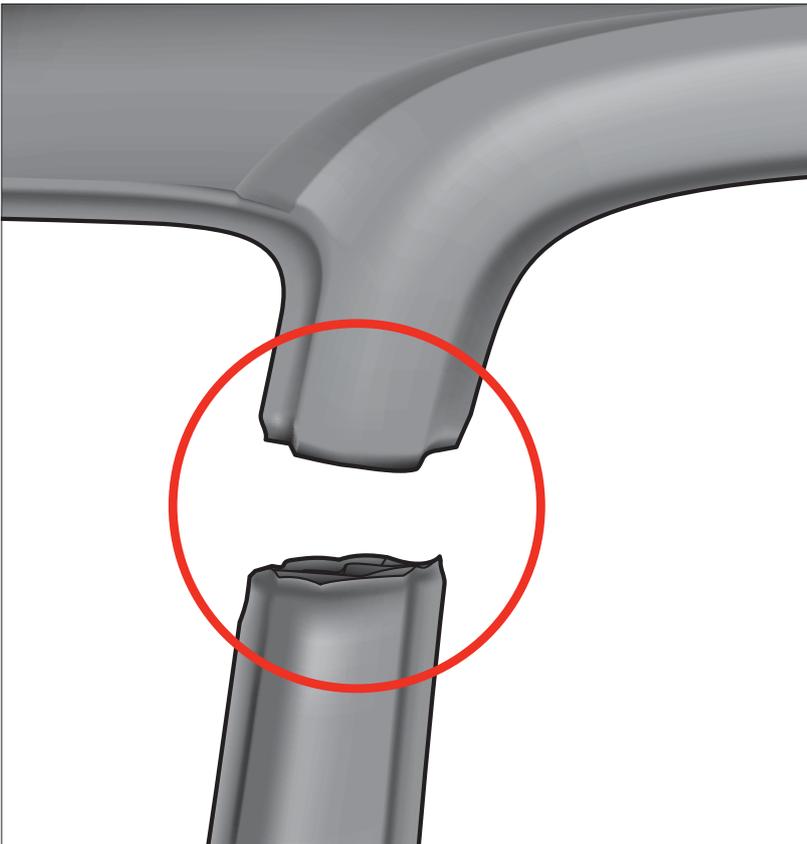
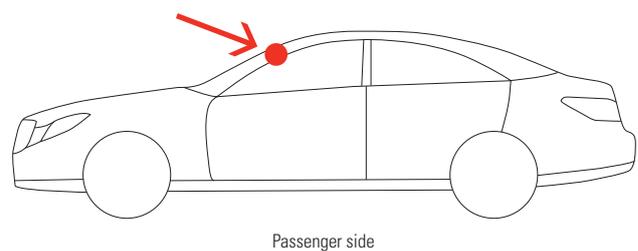
2.2 'A' pillar – cut

The 'A' pillar of a vehicle which has been cut (e.g. by emergency services personnel to permit occupant extraction).

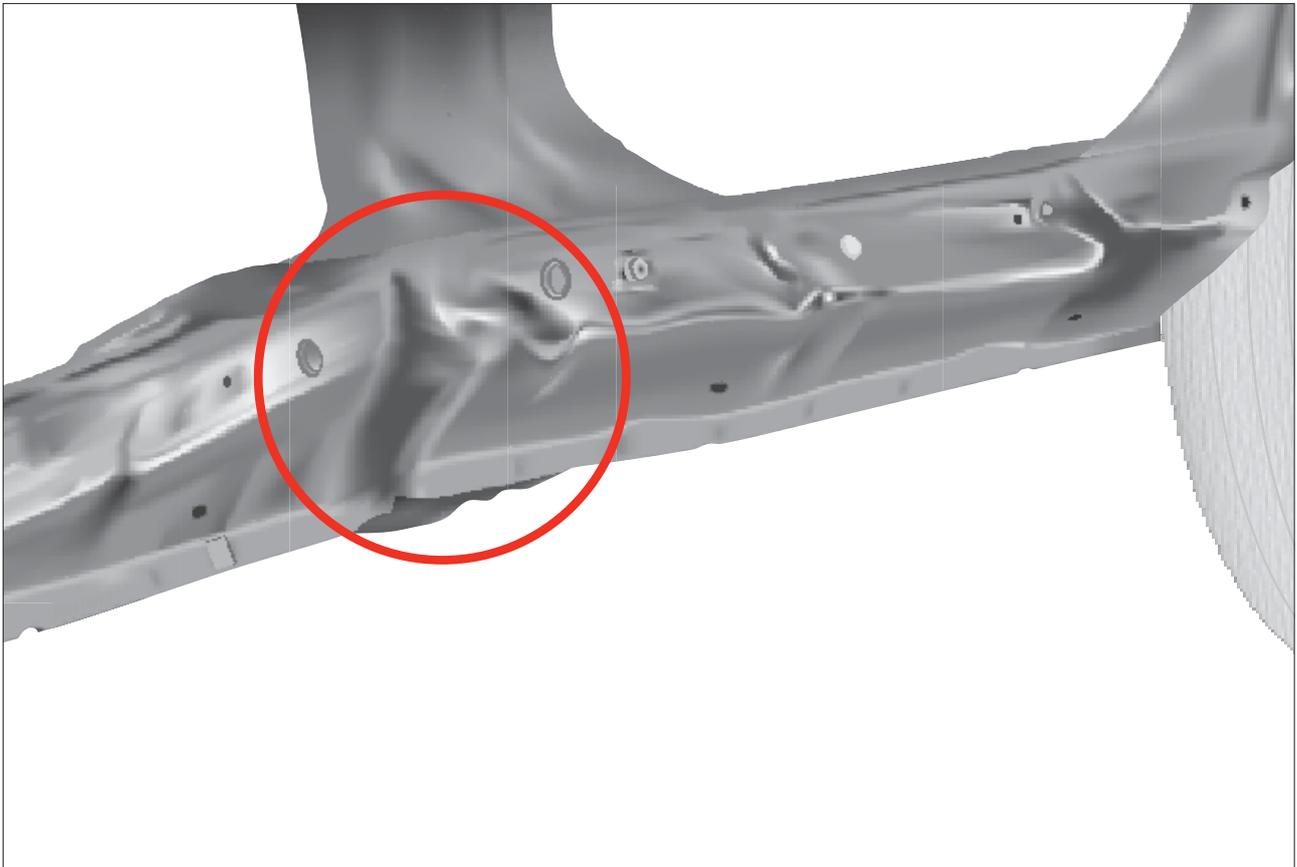
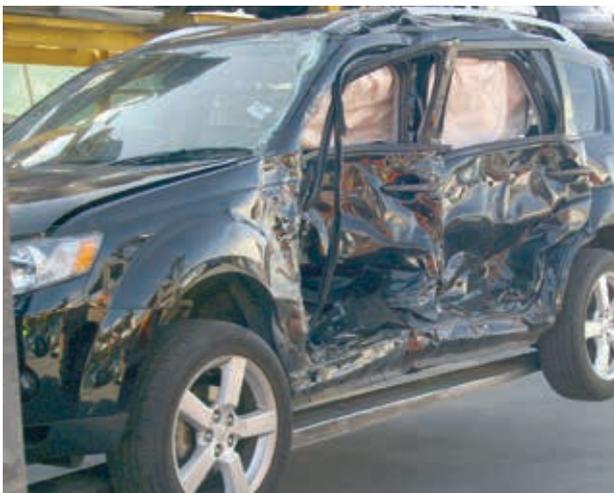
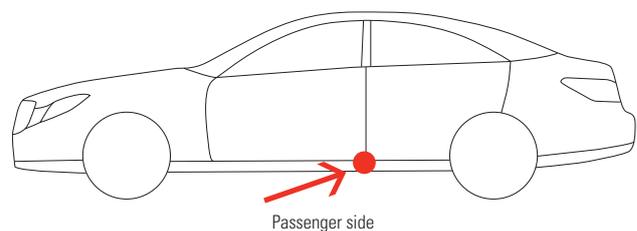
3.1 Floor pan – buckled

A side view of a vehicle showing buckling and folding of the floor.

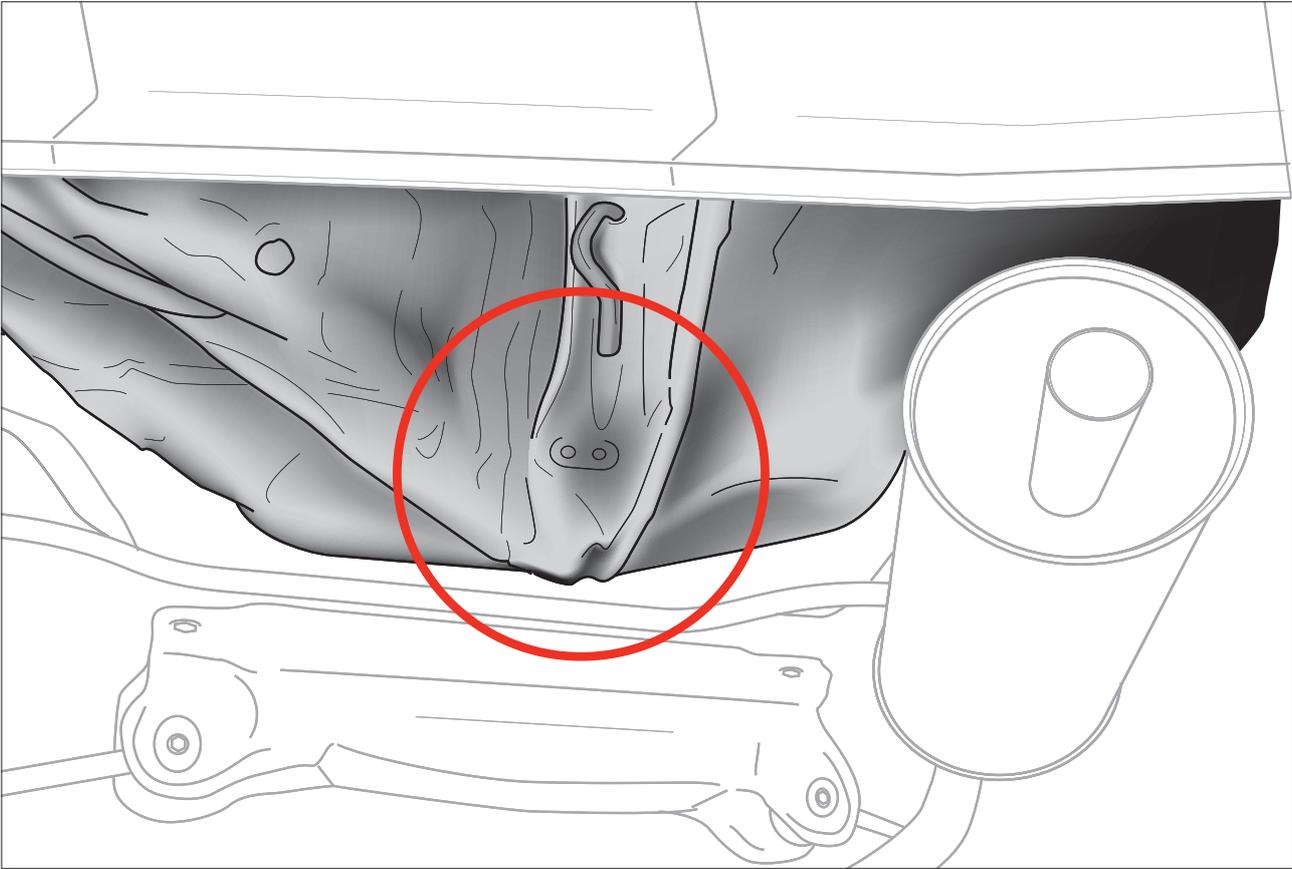
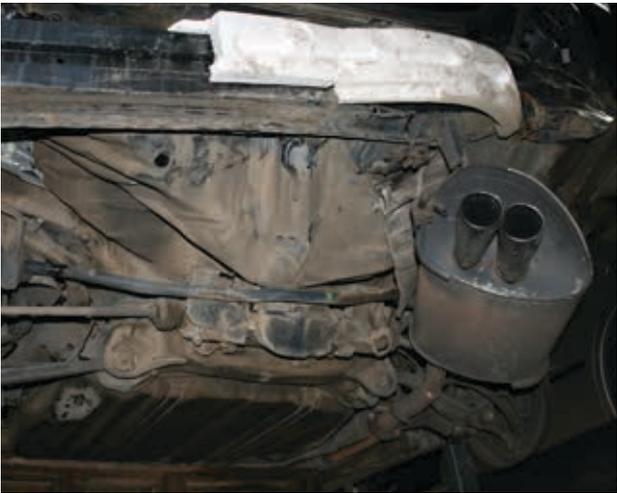
3.2 Floor pan – buckled

View of the rear underneath of a vehicle showing buckling of the floor pan.

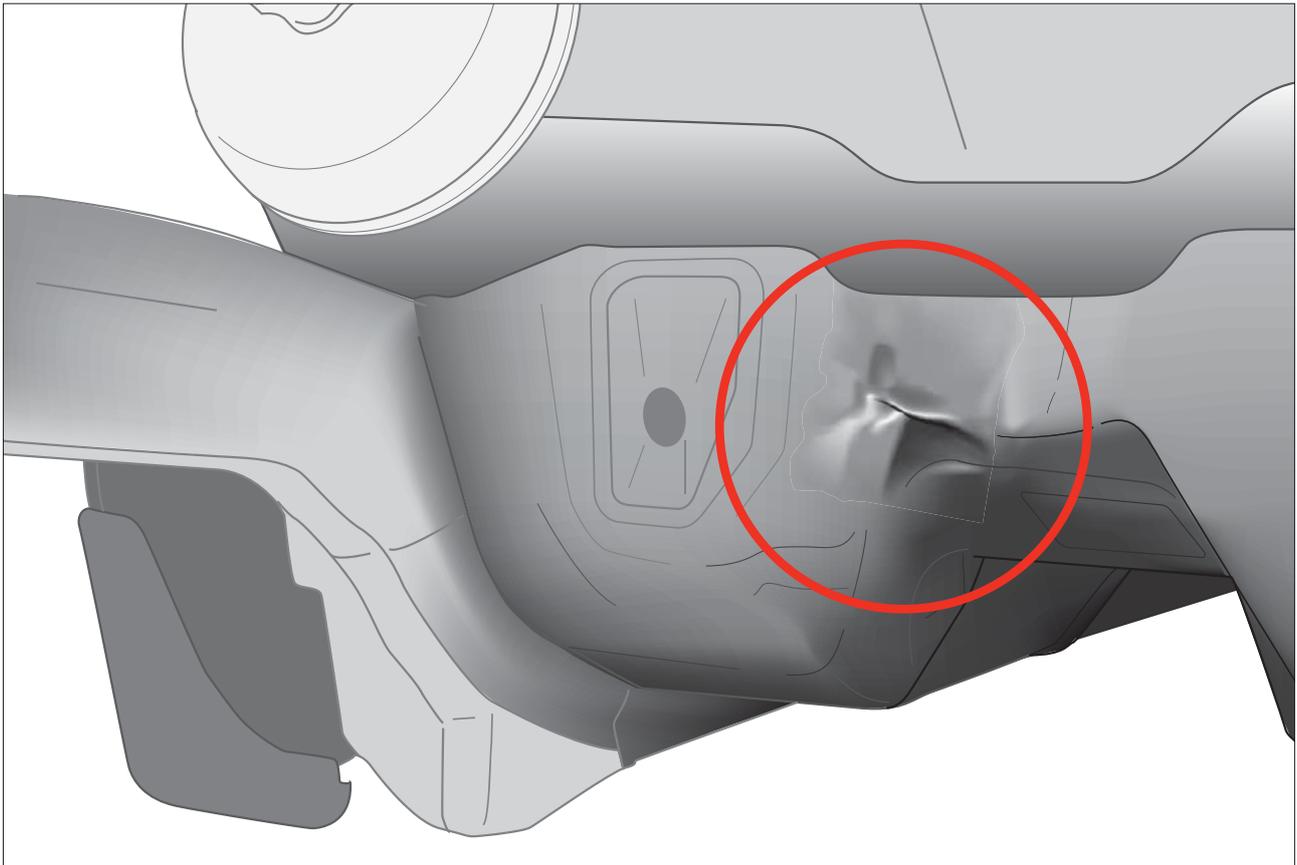
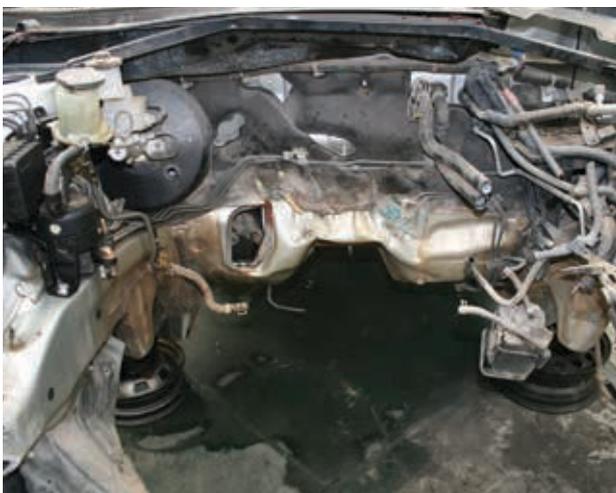
4.1 Firewall – folded

View of the firewall showing a fold induced by impact damage.

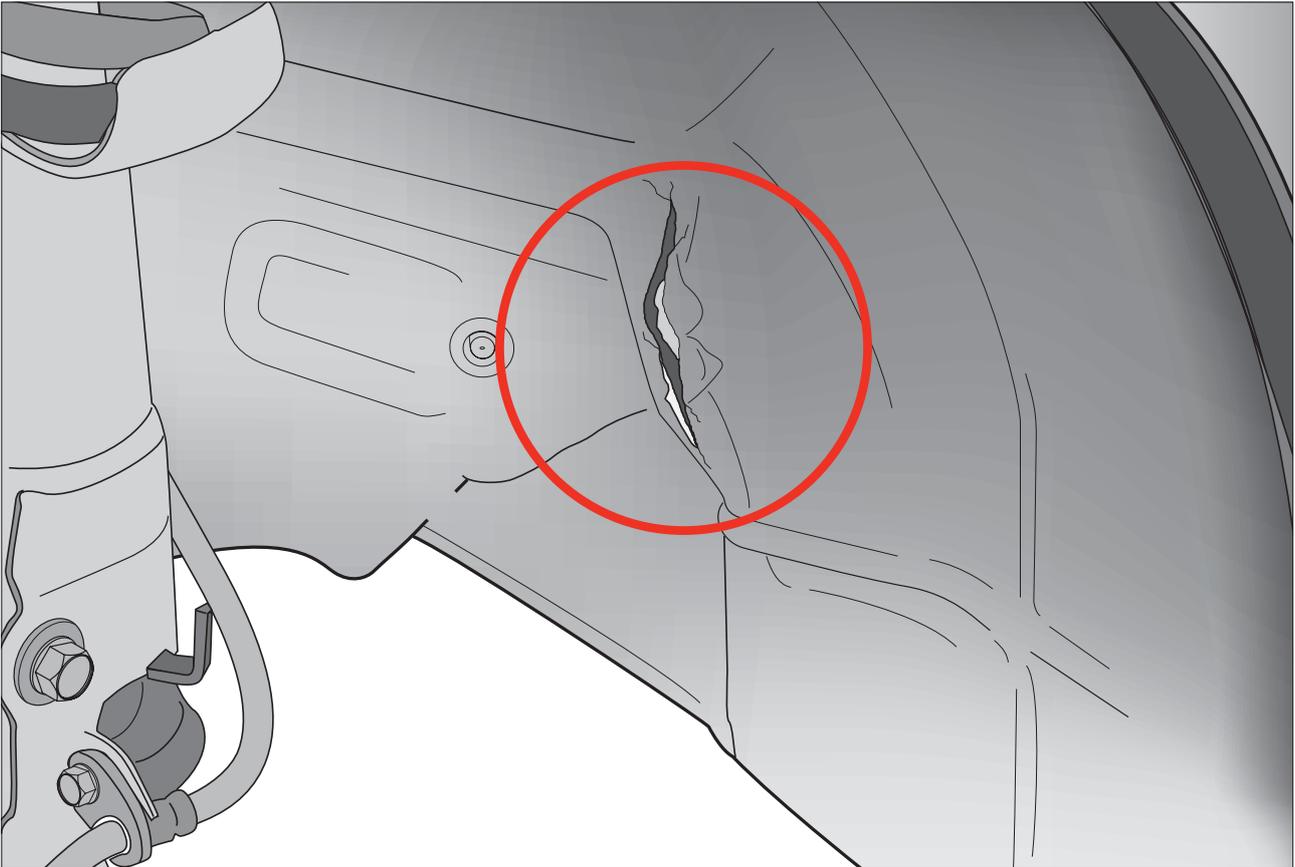
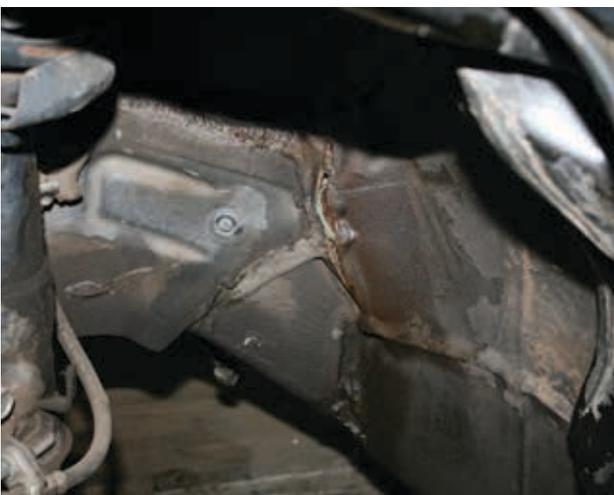
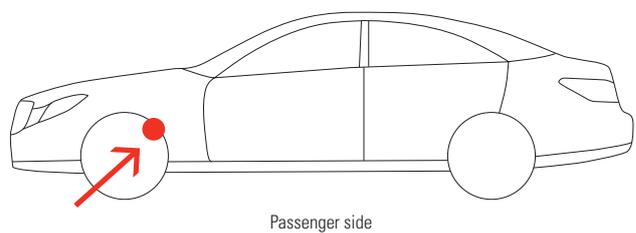
4.2 Firewall – cracked

View through the front left wheel-well of the firewall showing a crack in the firewall.

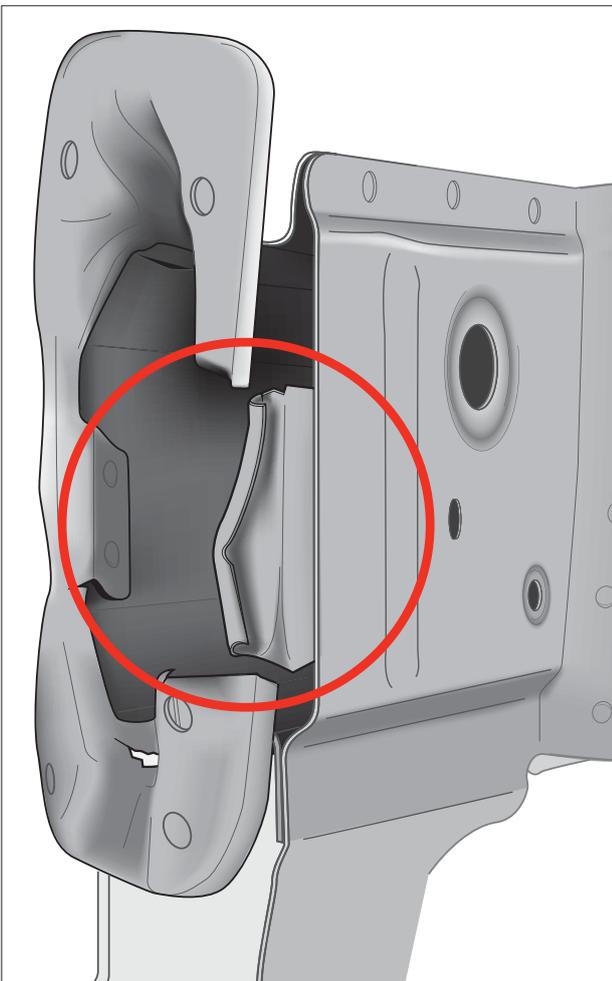
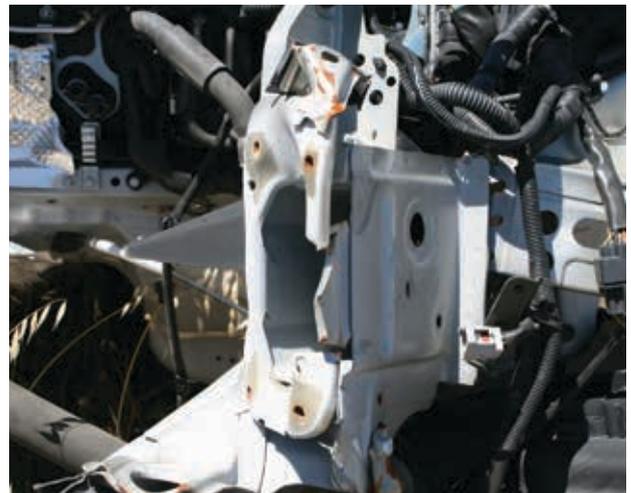
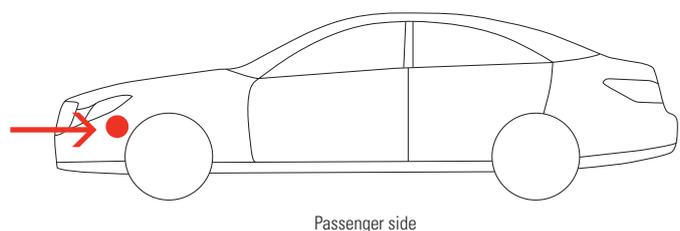
5.1 Chassis rail – fractured

View of longitudinal structural rail/chassis fractured due to impact.

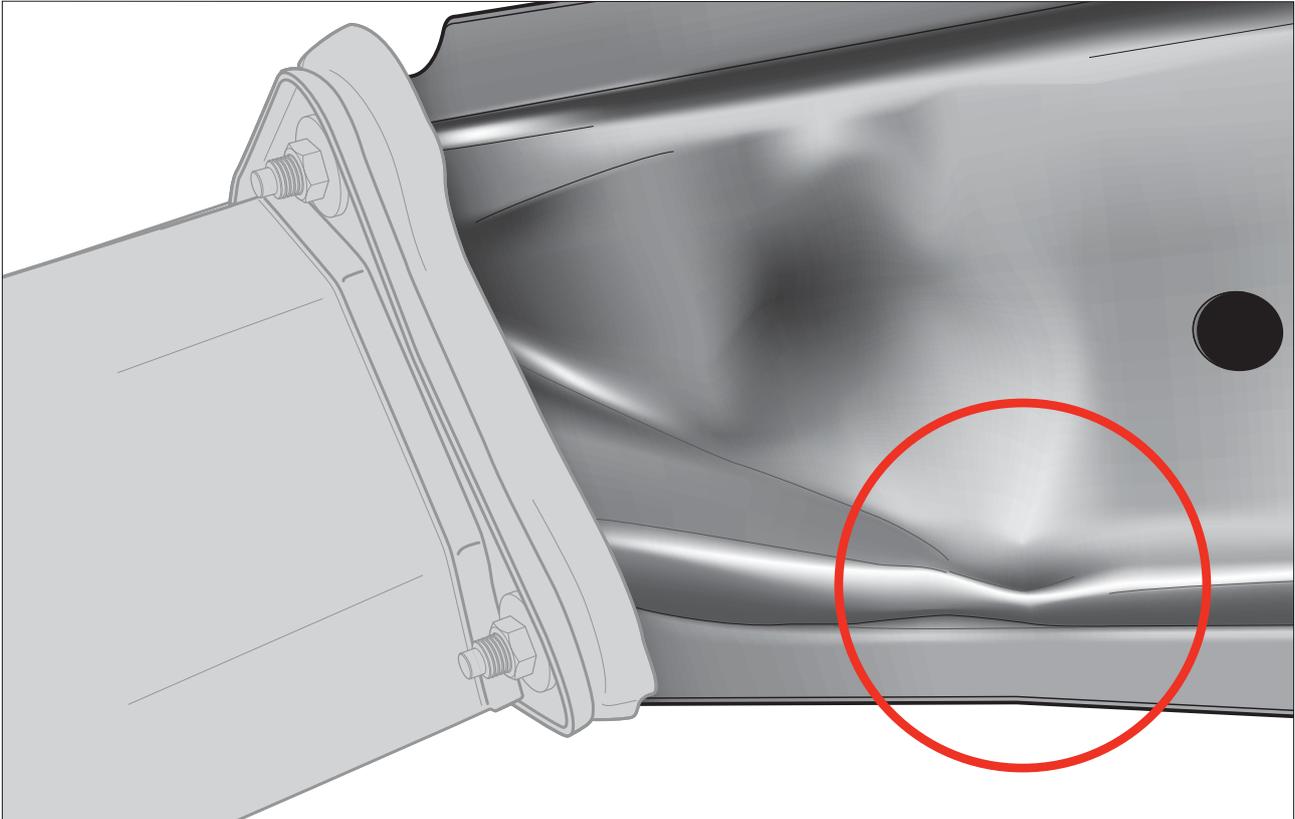
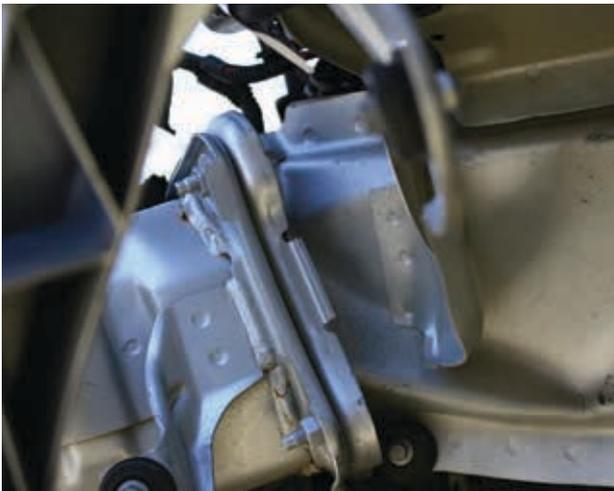
5.2 Chassis rail – buckled (side view)

View of a longitudinal structural/chassis rail which has buckled due to structural impact loading.

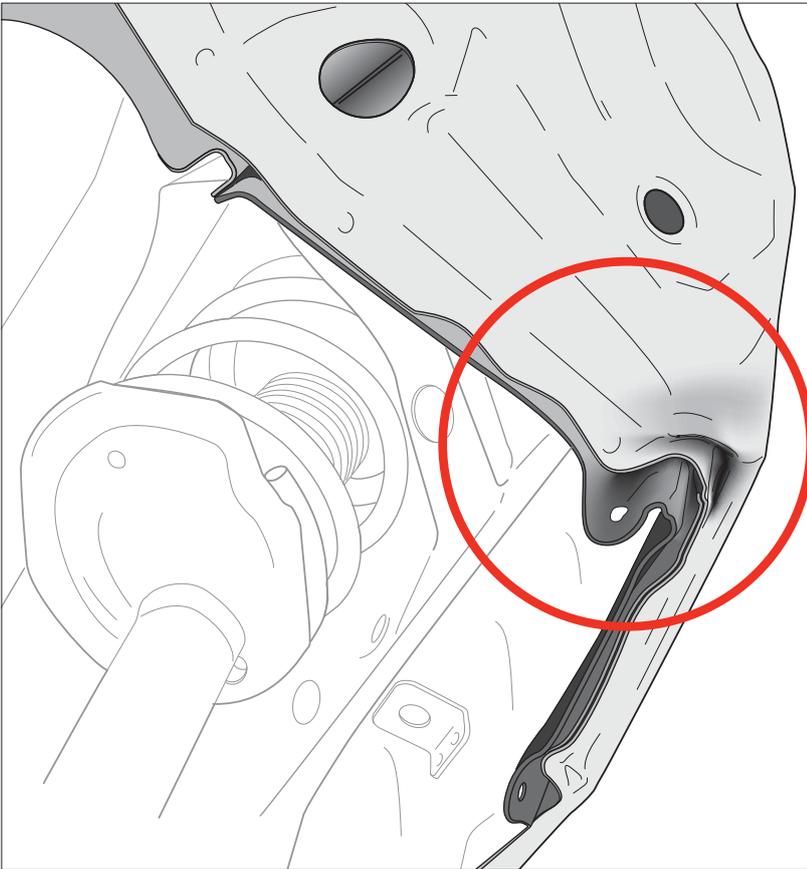
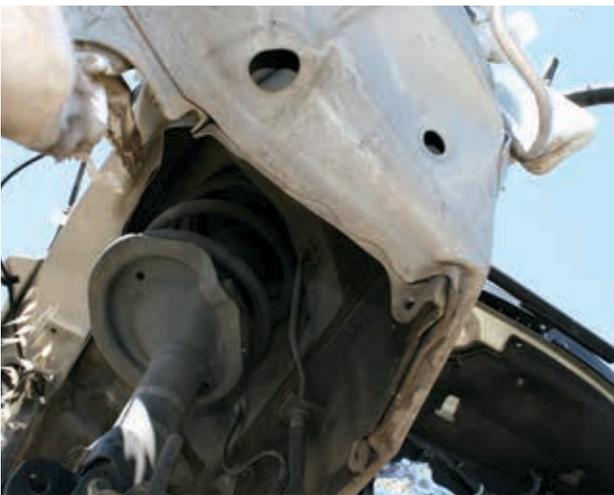
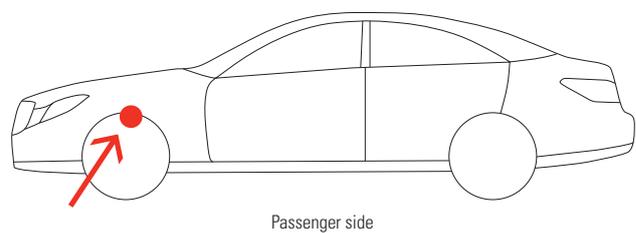
5.3 Chassis rail – folded

View of a longitudinal structural/chassis rail which has folded due to a side impact.

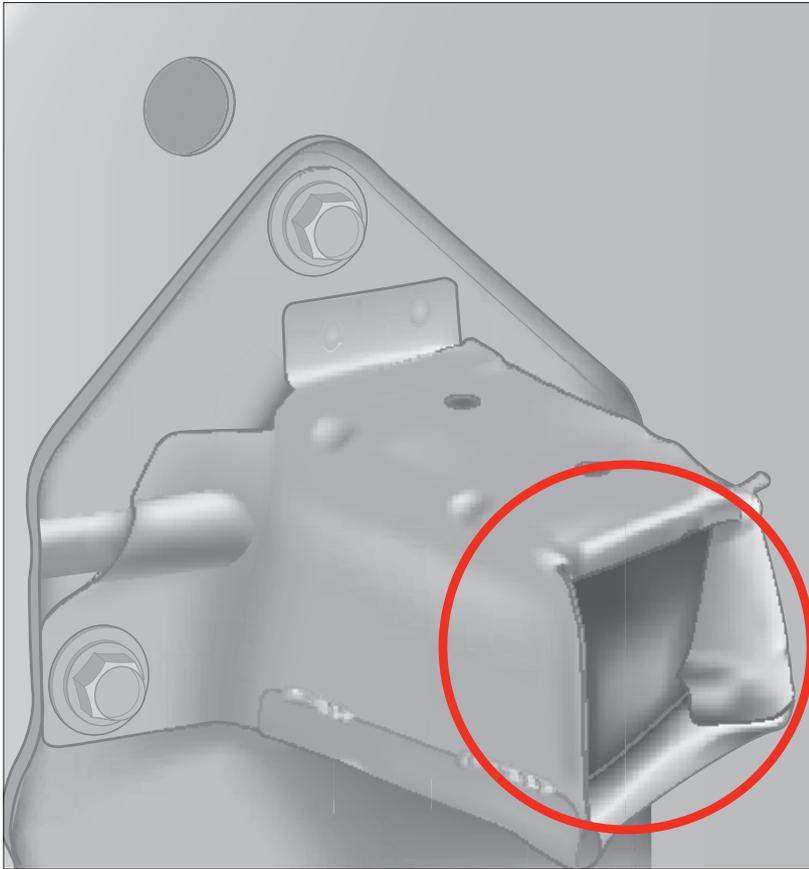
5.4 Deformable crush tube – damaged

This is an example of a deformable end plate that is designed to be removed and replaced. Such components are not to be registered as a damage count.

Note: A deformable member that is designed to be removed and replaced is not considered a fundamental structure of the vehicle if damaged and such components are not to be registered as a damage count.

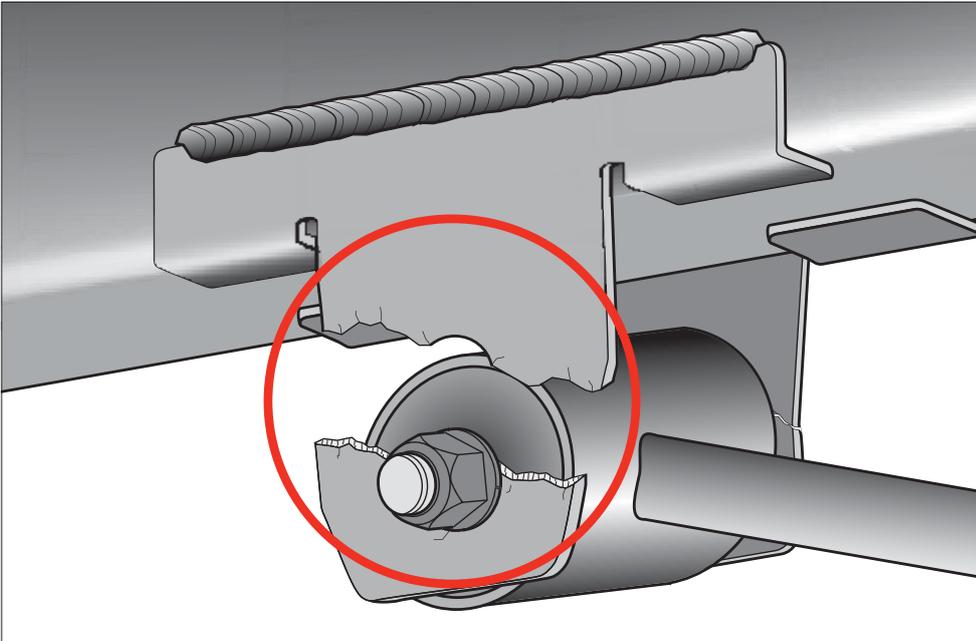
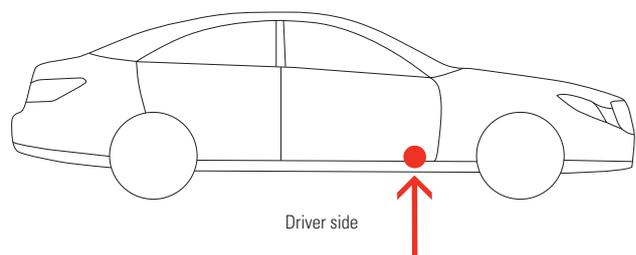
6.1 Suspension mount – fractured

View of a fractured suspension mount.

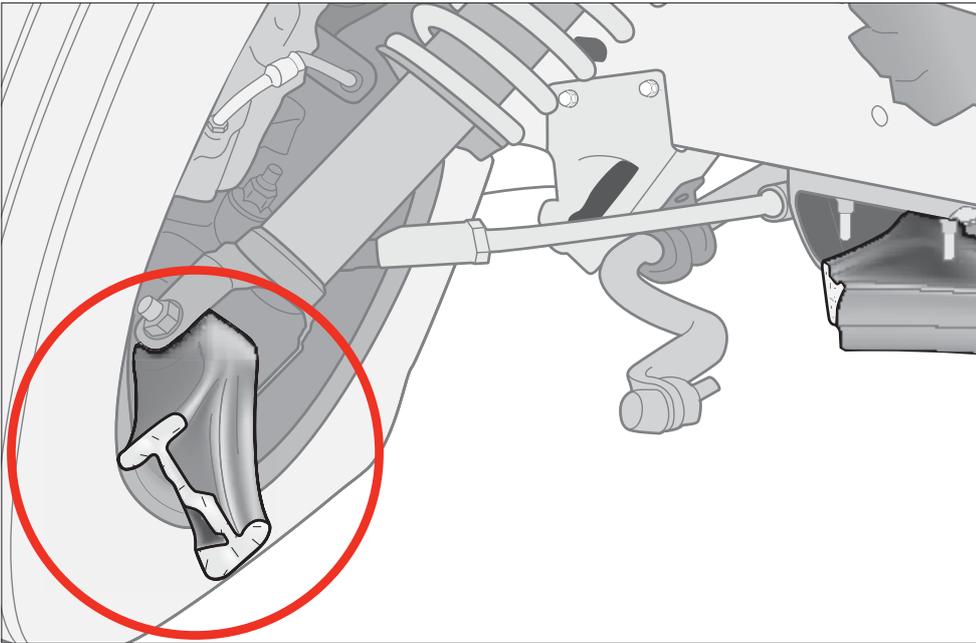
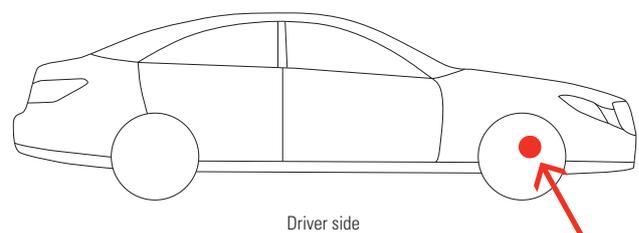
6.2 Suspension and linkages – damaged

This is an example of damaged suspension components that do not form part of the damage criteria because components such as suspension arms and linkages are designed to be removed and replaced.

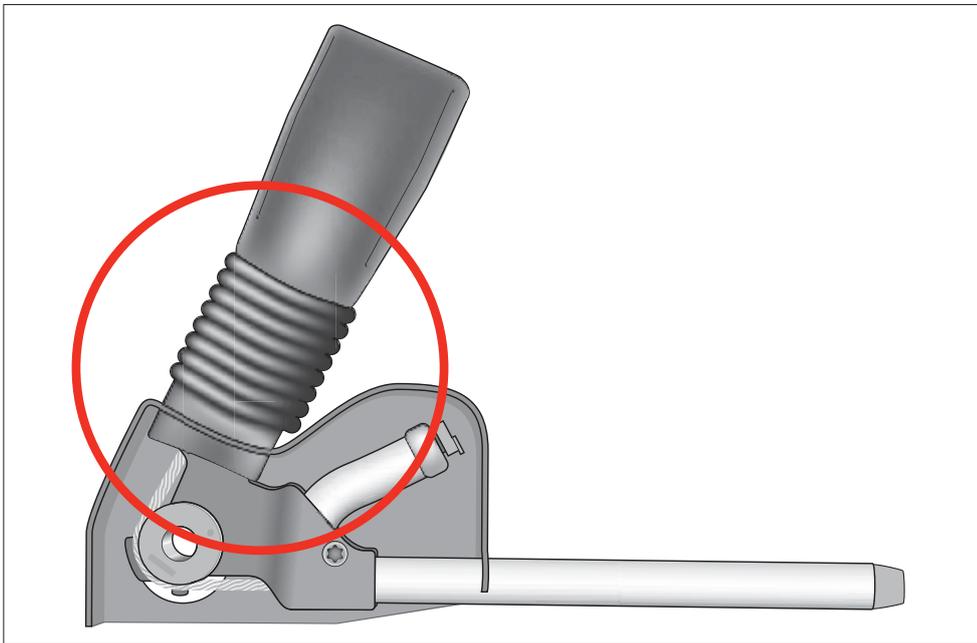
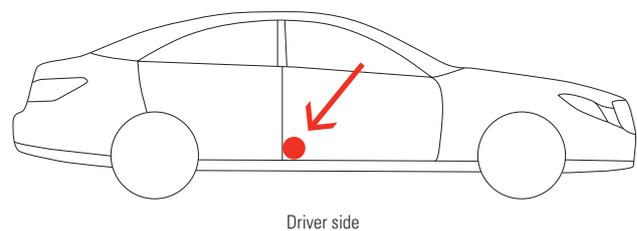
7.1 Pre-tensioner – active

View of a seat belt buckle showing a buckle with an active pre-tensioner.

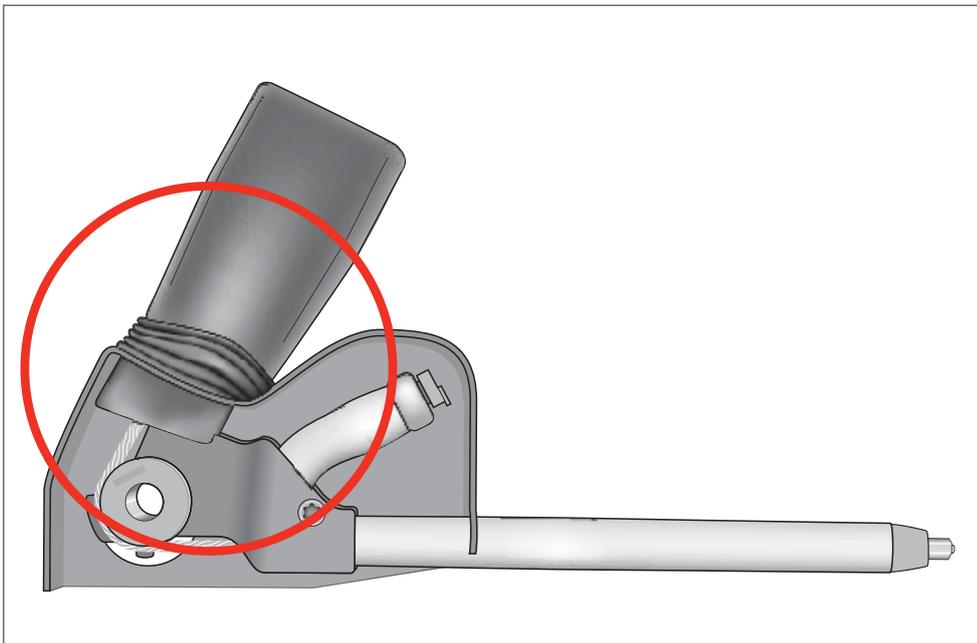
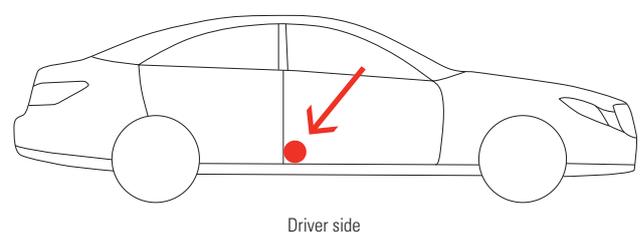
7.2 Pre-tensioner – fired

View of a seat belt buckle showing a buckle with a used pre-tensioner.

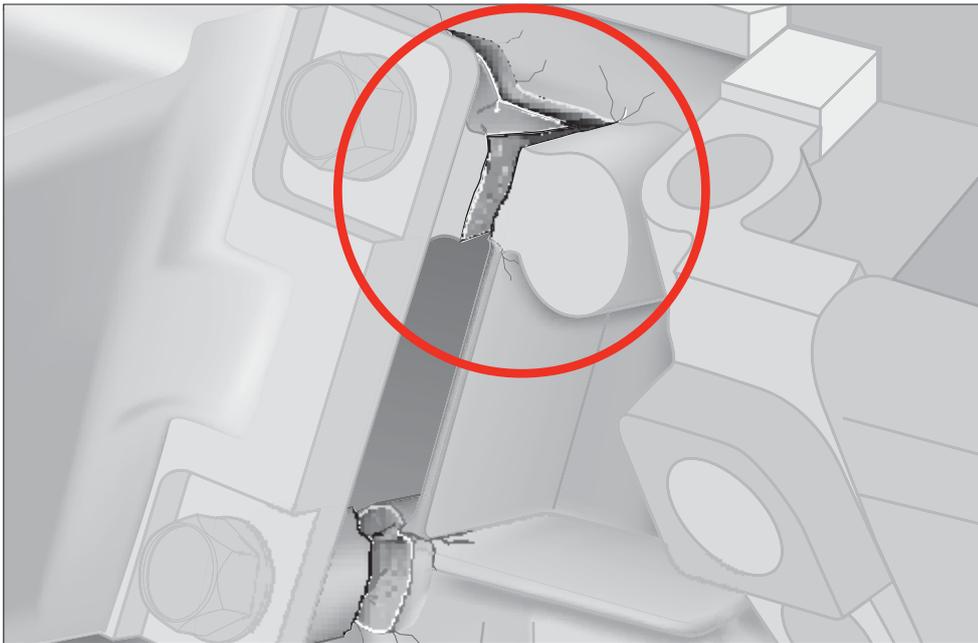
8.1 Engine mount – fractured

View of fractured engine and mount induced by a collision.
